BANFF AND KYLE FPSO AND FSO FLOAT OFF INTERIM CLOSE OUT REPORT

P0009-CNR-EN-REP-00011

Draft Decommissioning Programmes

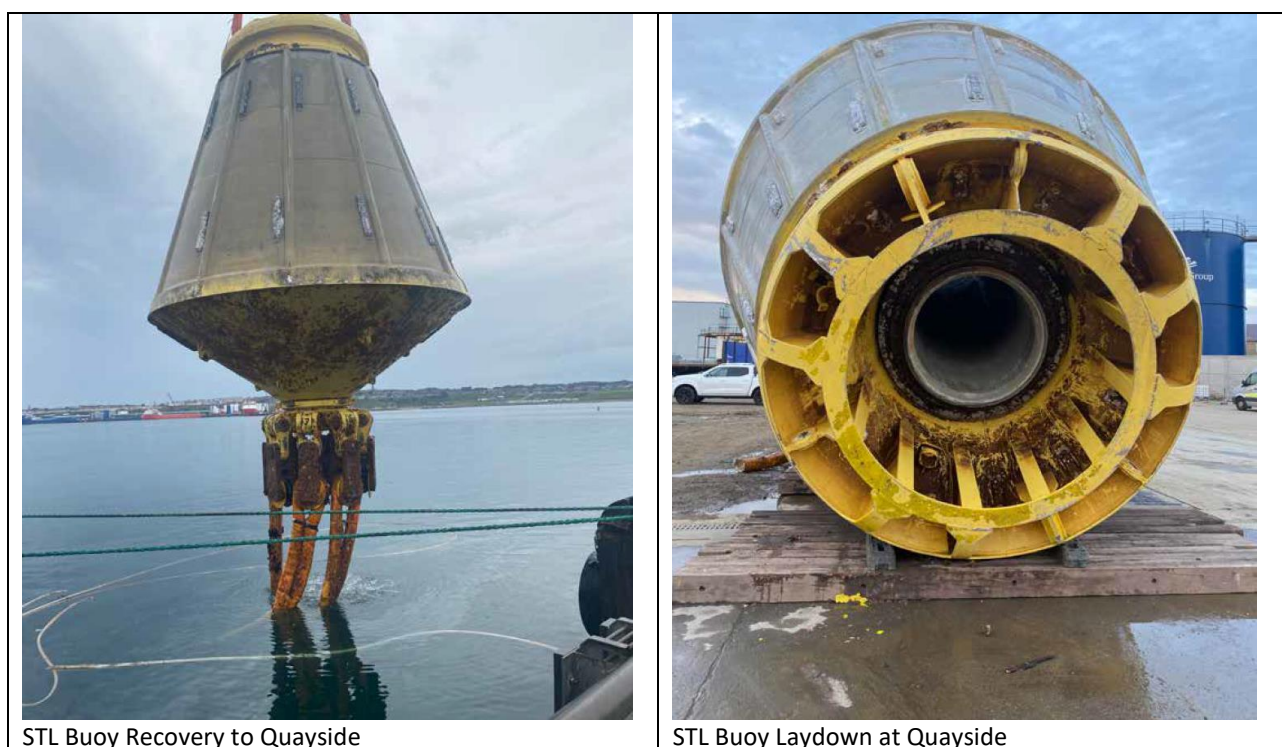
Figure 5.1: STL Buoy Recovery

The STL Buoy was towed to shore and recovered at Smith Quay, Peterhead. The management of the STL Buoy was undertaken by John Lawrie Metals (JLM) alongside NorSea. The STL Buoy was broken down into its steel components as shown in Figure 5.1 and recycled.

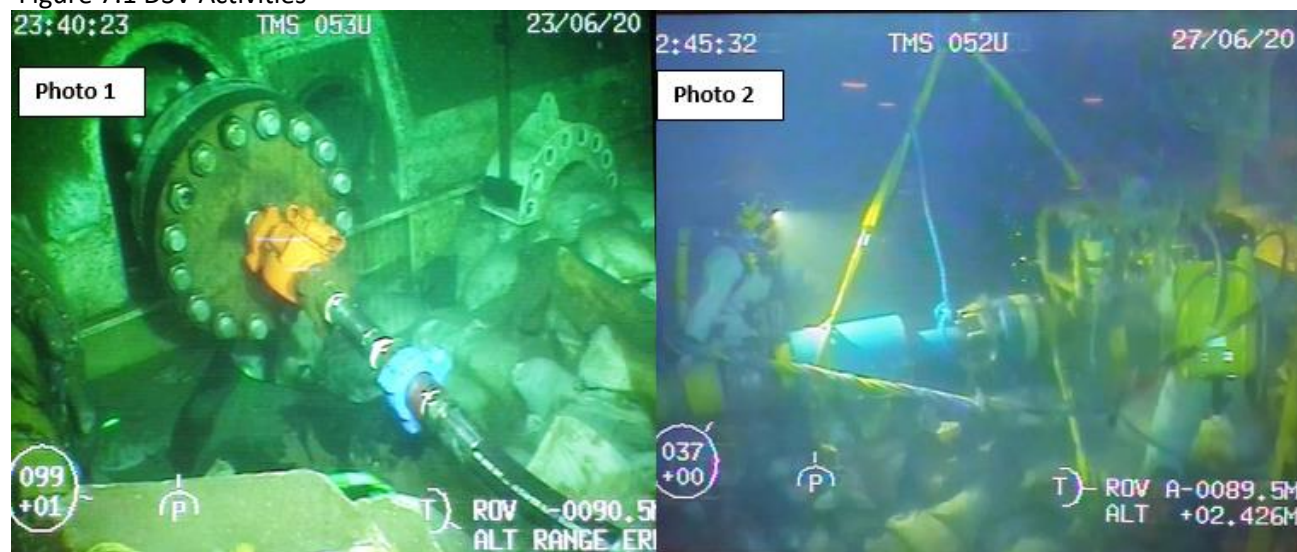
Figure 7.1 DSV Activities

Photo 1: 12 inch dead leg flushing blind during flush on Kyle South Manifold. Photo 2: Divers prep to remove 6 inch spool piece from K15.

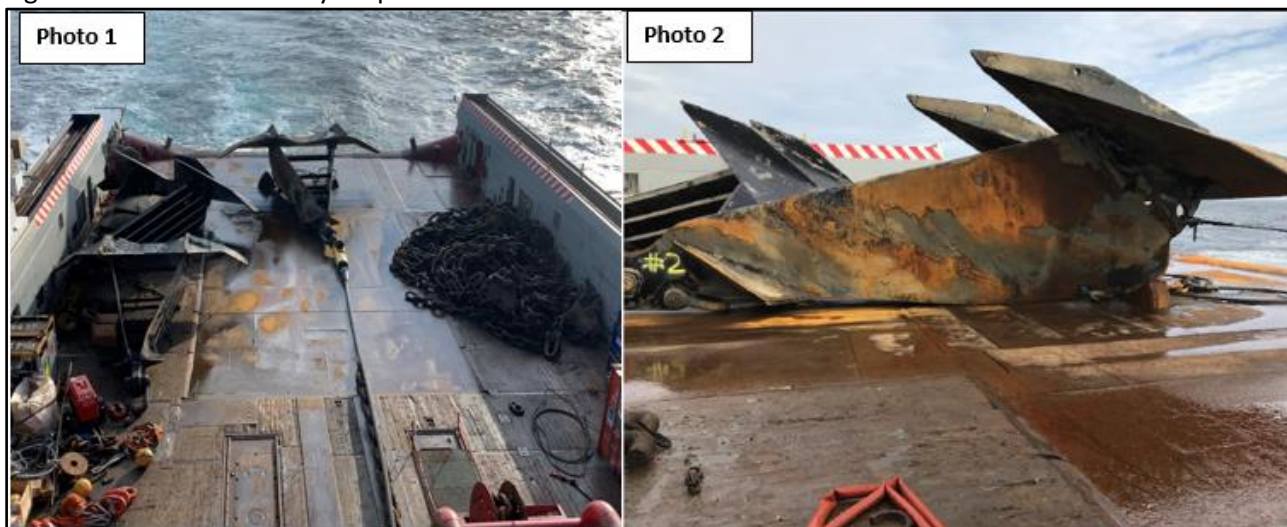
Figure 7.3 Anchor Recovery scope

Photo 1: Anchor recovered to deck. Photo 2: Banff Anchor 02 Stevpris 50 Te.

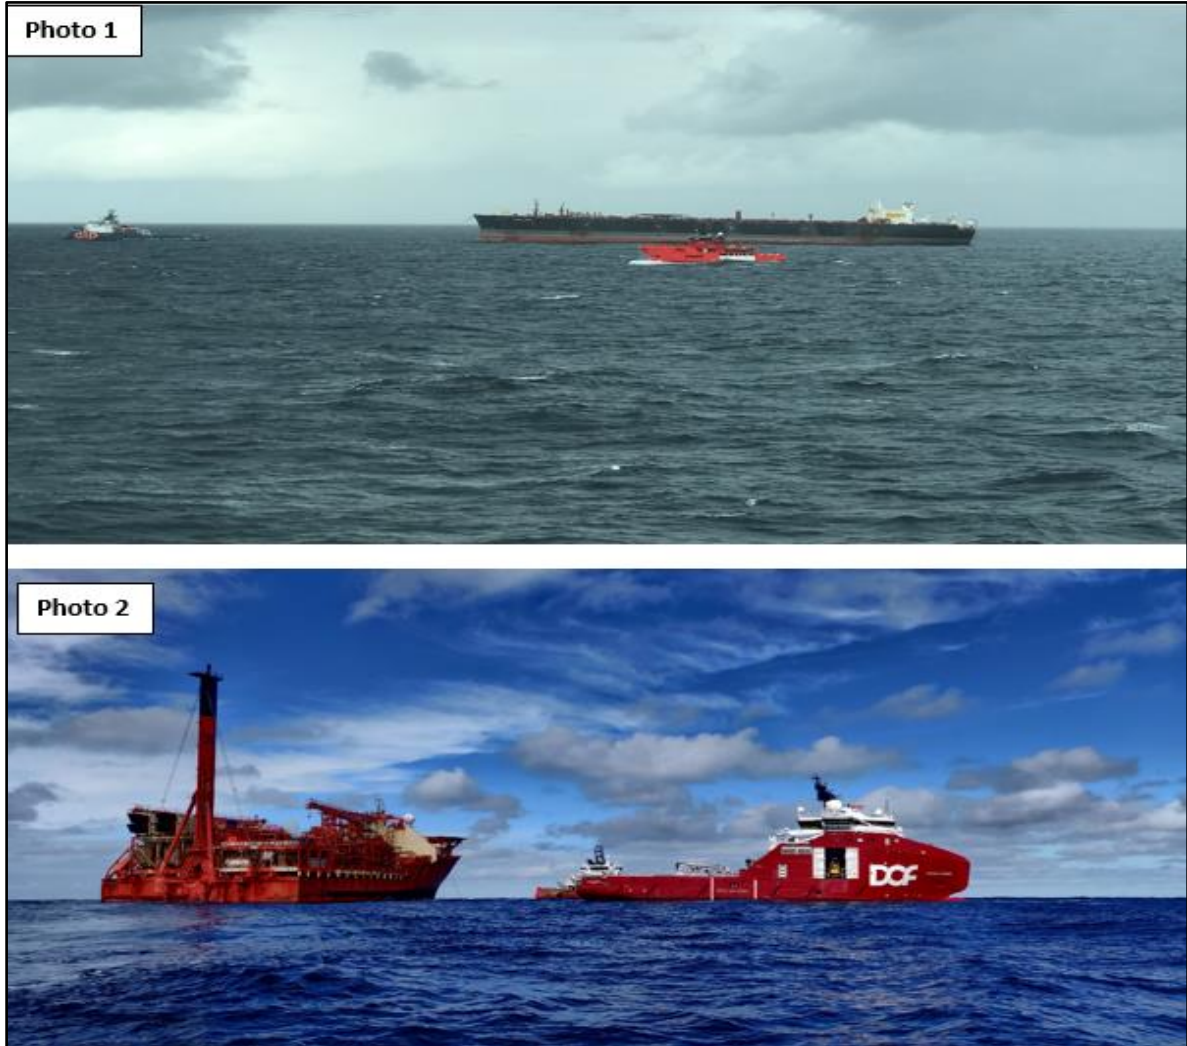
Figure 7.5 FPSO and FSO Sail away

Photo 1: Apollo Spirit FSO being towed. Photo 2: Petrojarl Banff FPSO being towed by GH Atlantis on route to Kishorn.

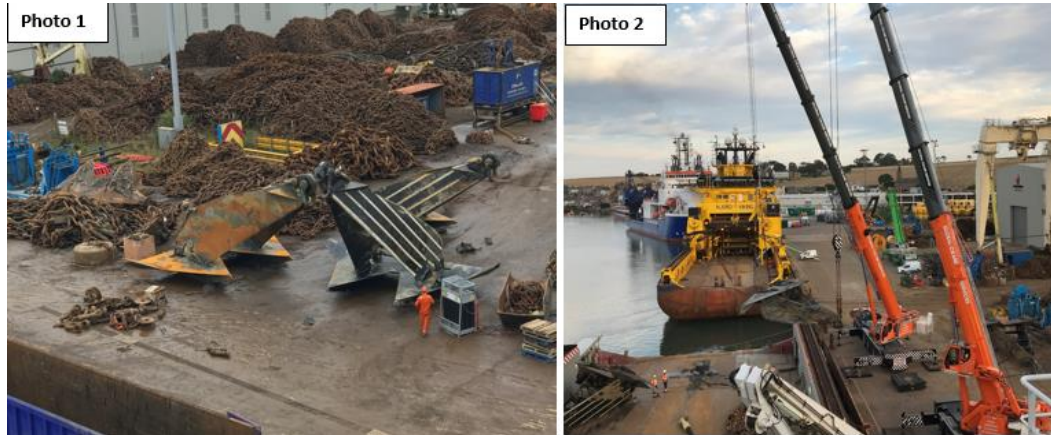
Figure 7.6 Anchor Offloading Onshore

Photo 1: Banff Anchor lifted onto quayside. Photo 2: Tandem crane lift in Montrose Port 6th September 2020.
